## **Pin Oak (*Quercuspalustris*)**

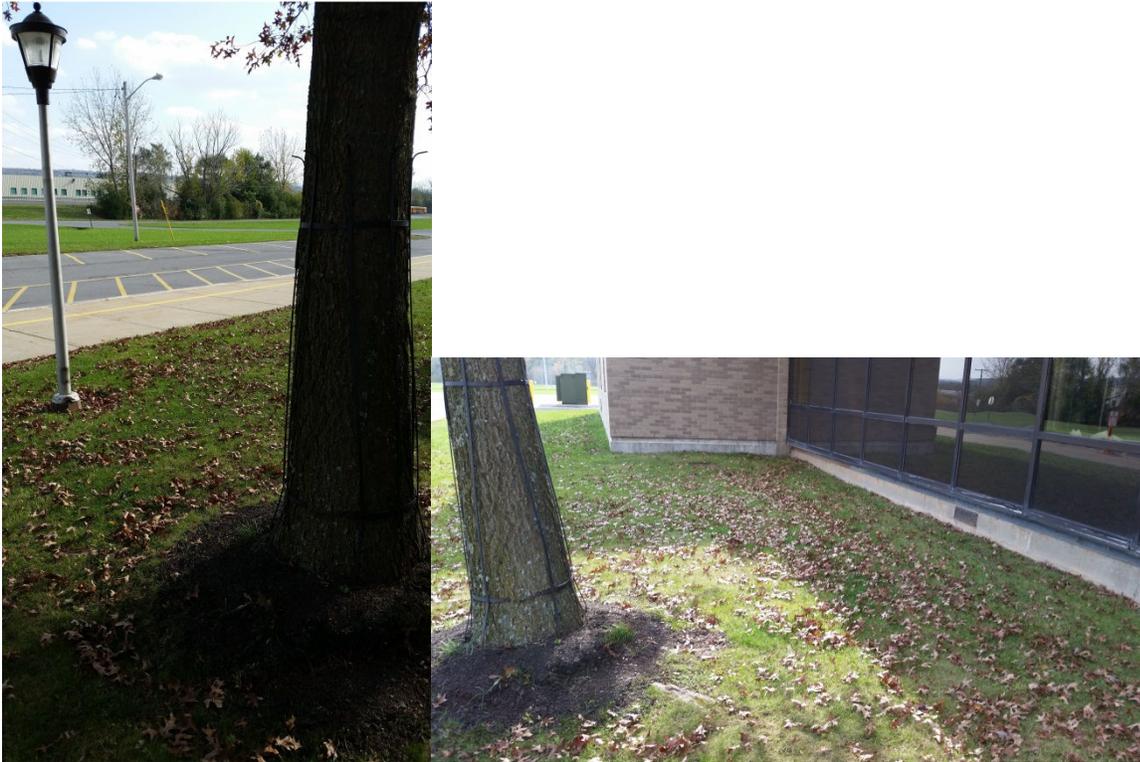
This particular tree has no visible signs of rot/decay or fungi and has a good full crown. The tree appears to be in good overall health.

It is possible the iron fence could be growing into the root structure at the base of the tree which was not visible and would require digging around the base of the tree to view. The tree sits in close proximity to the building and light post and according to Bill Lachette the Facilities Director; there is a sewer line that runs under the tree. Tree roots have the potential to compromise the sanitary sewer line. Replacing the sewer line in the same location would obviously require the tree to be relocated or removed. If the tree is relocated, items of concern: Relocation may require substantial alteration of the fibrous root system. It is possible that the roots could be growing around the sewer line and electric line that leads to the light post. It is possible that a large portion of the root system would most likely have to be cut and removed resulting in added stress to the tree.

Because there may significant unforeseen alteration to the root system as previously stated, the tree may not survive the relocation process. If the decision is made to relocate the tree it is recommend that the tree is relocated while it is in its dormant state which would be November through February. It is not recommended that the tree be relocated due to the above situations . Perhaps it would be more logical to plant a new Pin Oak to serve as a memorial tree. Although these trees are naturally found in poorly drained soils, they are able to flourish on well drained loamy soils and are intolerant of shade.

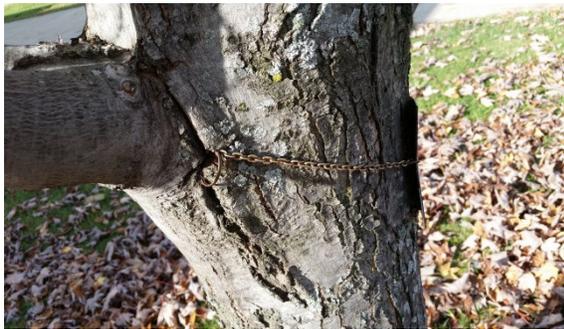
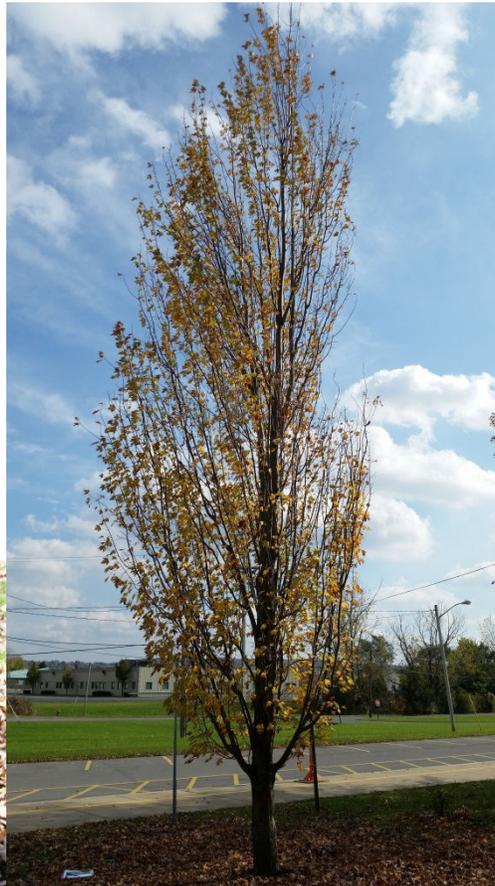
This particular tree appears to be somewhat healthy with an irregular crown shape which appears to be full. The tree also has a short bole (trunk) with the majority of twigs and branches pointing upward which may indicate stress.

The tree has grown around a chain that holds the dedication plaque which could act as a conduit for pest and pathogens. The irregular crown shape and short bole could indicate that tree has undergone periods of stress over time such as drought or physical damage. According to Bill Lachette the Facilities Director; there is a sewer line that runs under the tree which may cause the same issues as stated for the Pin Oak. Another concern is that school has acted as a wind-break for the tree during its life span and may have not developed a resiliency for strong winds. If the tree were to be replanted in an open field it may be susceptible to wind damage due to the tree's irregular form and the possibly weak section of the bole that has grown around the chain.

Because of the possibility of wind damage and poor form possibly due to previous stressors it is not recommended that the tree be relocated. If the tree were to be relocated it would be best to relocate the tree during its dormant state which would be November through February. It may be more logical to plant a new Red Maple tree. Red maple tend to grow well in moist soils, but can thrive in a variety of soil types and are moderately shade tolerant.
